Repair Techniques for Celion/LARC-160 Graphite/Polyimide Composite Structures

J. S. Jones and S. R. Graves

**CONTRACT NAS1-16448
JUNE 1984**

J. S. Jones and S. R. Graves
Rockwell International
Downey, California

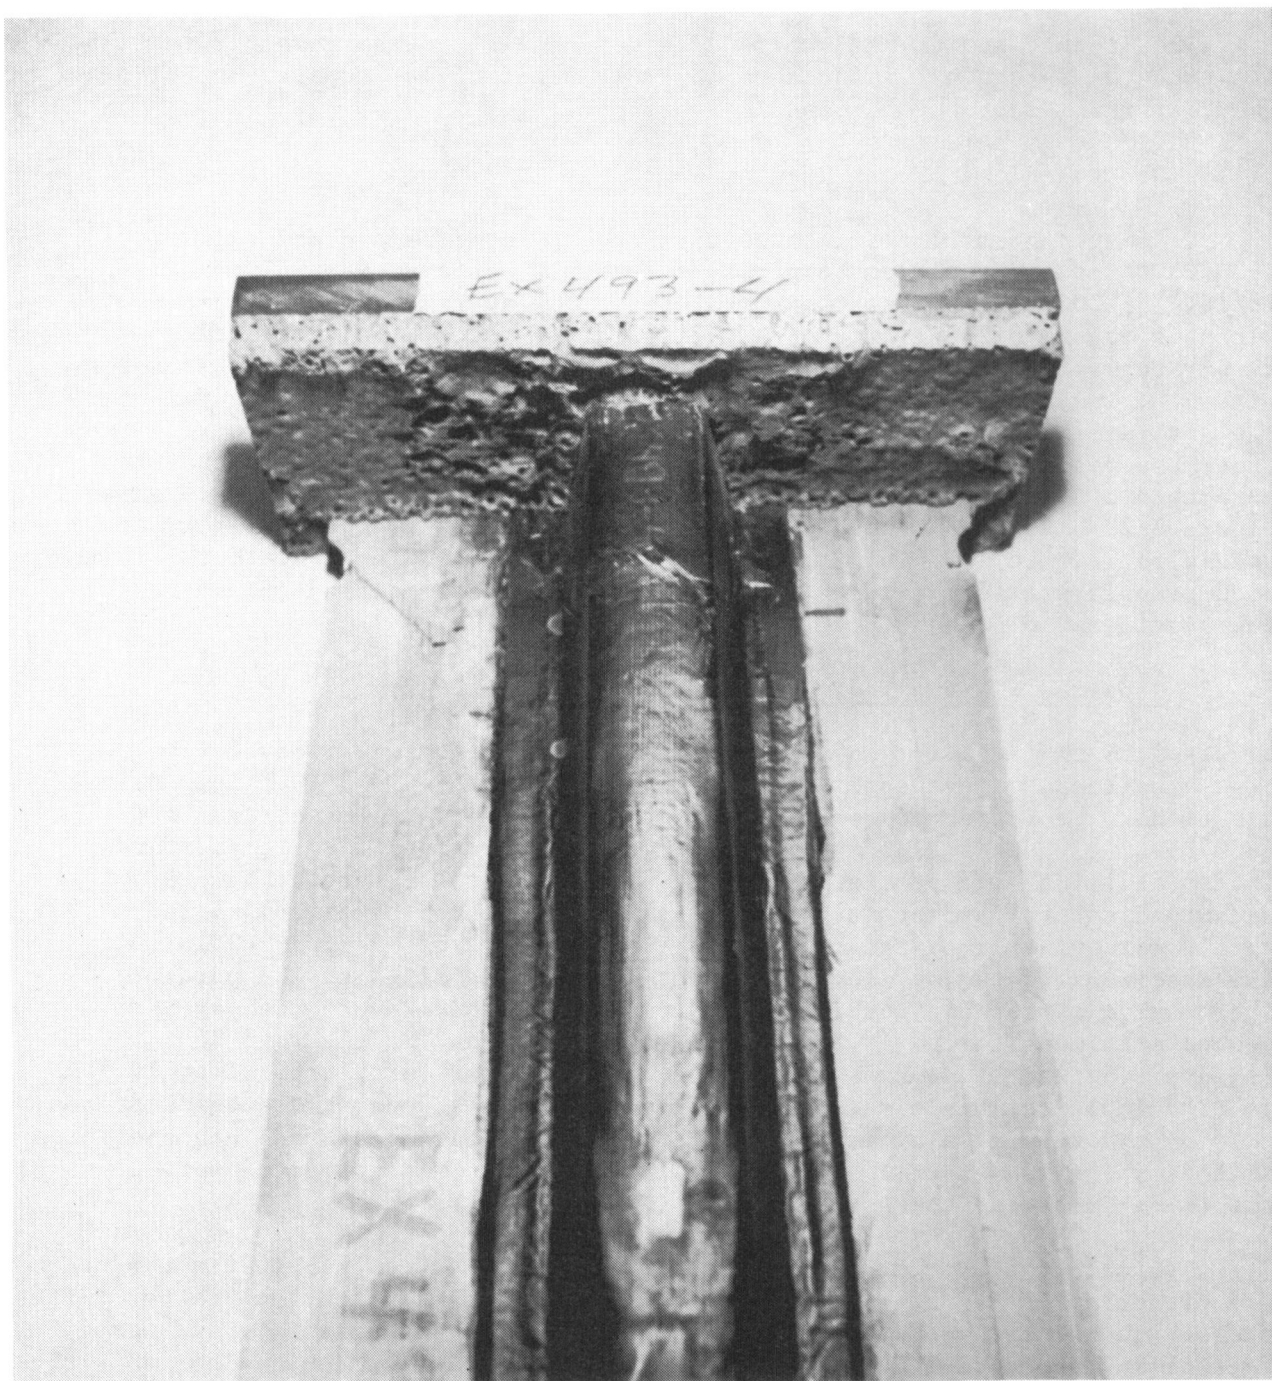
Figure 8-25. Failure Mode of Heavily Loaded Repaired Hat Stringer
Element Tested at 316°C (600°F)

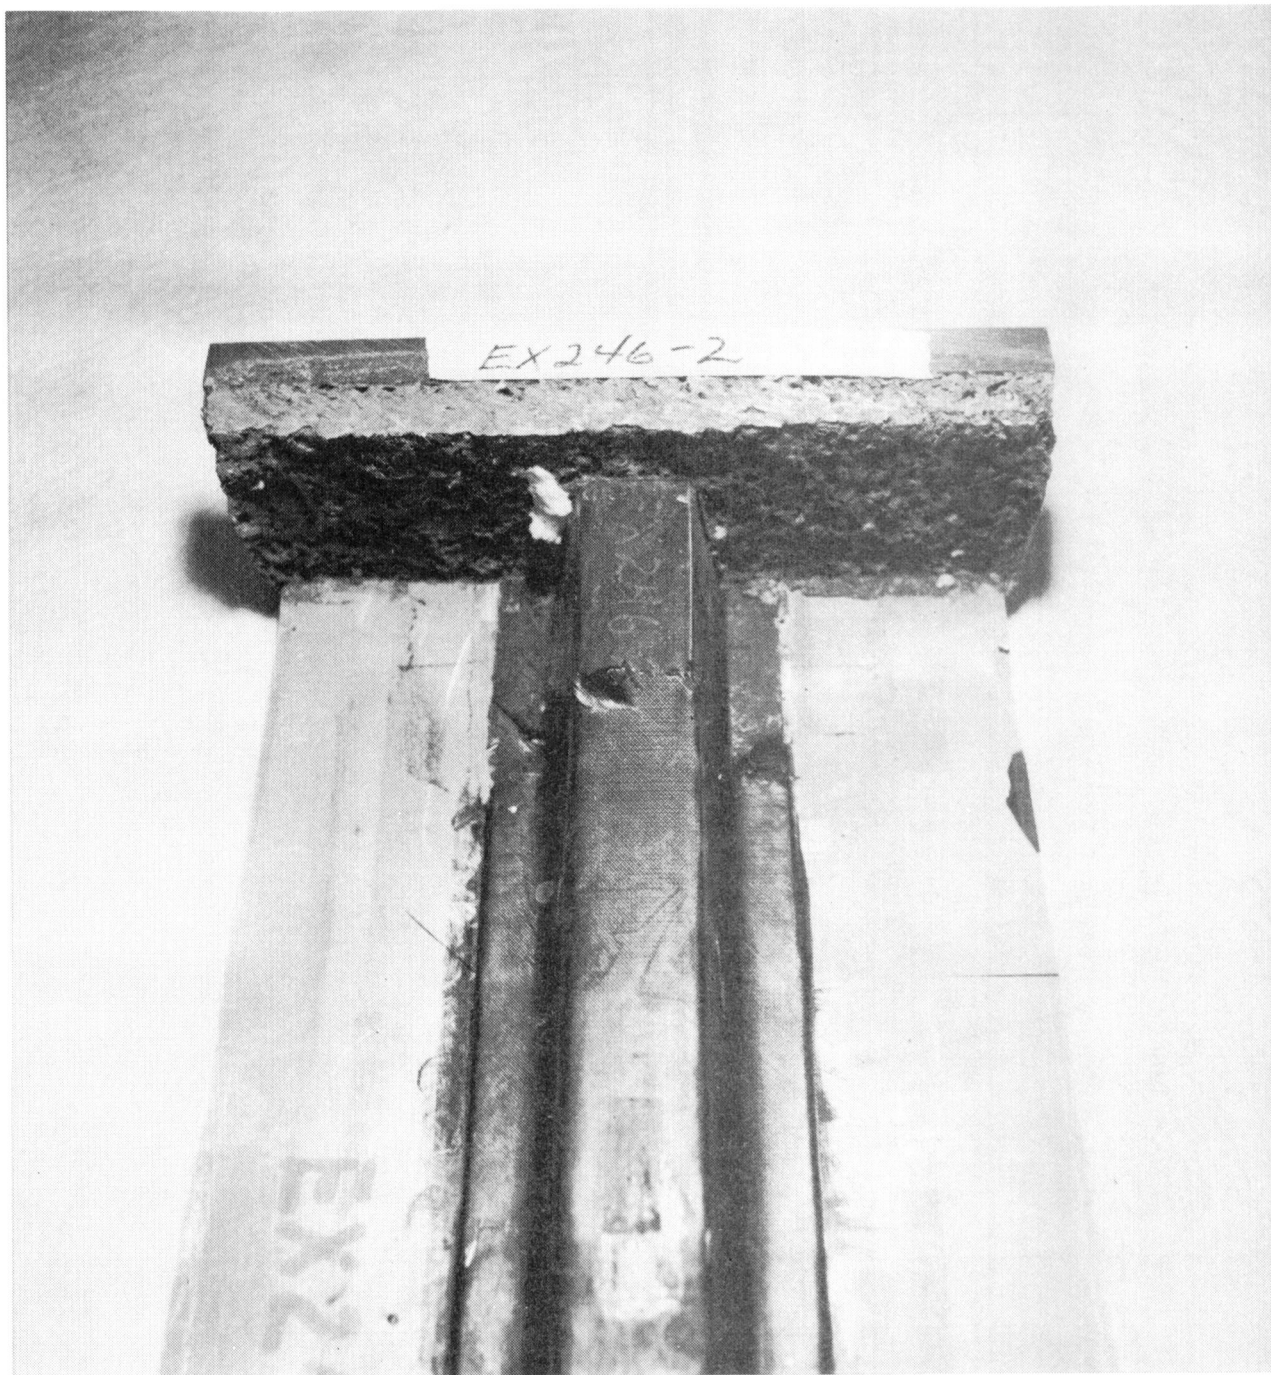
Figure 8-28. Failure Mode of Lightly Loaded Repaired Hat-Stringer
Element Tested at 316°C (600°F)

Typical load-strain responses of the lightly loaded hat-stiffened panels are presented in Figure 8-27. In both the room and elevated temperature tests, the strains at each point were nearly equal, except for gage 4, which was located in the total thickness repair area. The material at that point in the cap has a higher elastic modulus because of the added 0-degree plies (see Figure 8-19). The specimen tested at 316°C (600°F) failed at 67 percent of the room temperature repair strength. A typical failure mode is shown in Figure 8-28.
